Issue Date: 26 JUL 10

Subject: Incorrect Installation of Chute Locking Nuts

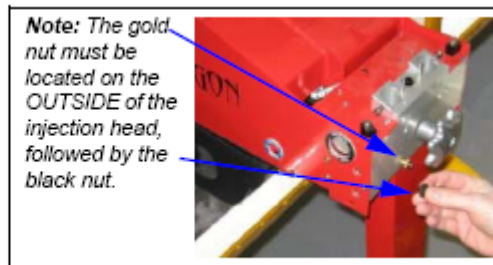
Several incidents have occurred when an operator incorrectly installed the outlet chute to the injection head. The gold nuts were left on the chute screws on the inside of the head and the black nuts on the outside. This action caused the chute to be offset inboard and blocked the primed spheres from exiting the dispenser.

To prevent further occurrence, page 22 of the Red Dragon Operations manual has been revised with a note to clearly identify that both sets of nuts need to be on the outside of the injection head.

- Attach and secure the outlet chute, using a thumbnut and locking thumbnut on each screw.
