**Issue Date:** 12 AUG 14

**Subject:** Incorrect Position of Hopper Motor Plate

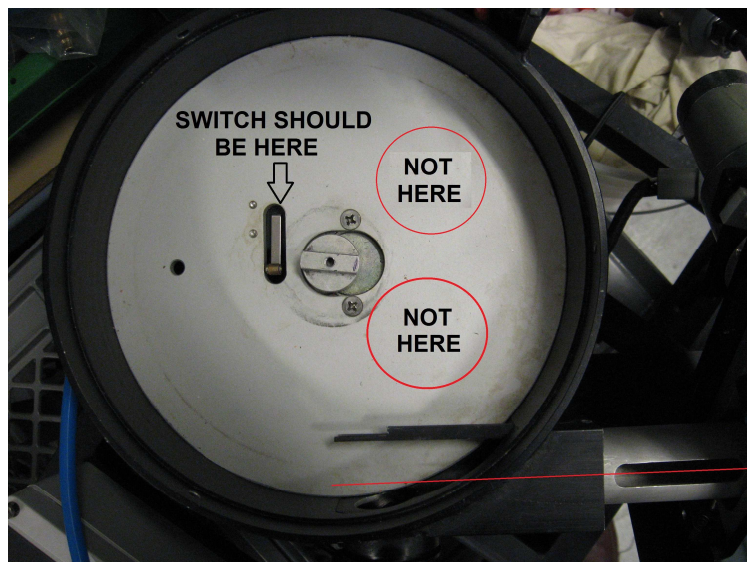
A Green Dragon dispenser was reported to have repeated problems with failure to load the primed sphere. Upon investigation, it was discovered that the motor plate in the hopper had been installed incorrectly. The motor plate is located in the hopper tube by three screws located 120° apart and includes the hopper limit switch which determines the position of the selector plate when it is stopped.

The motor plate and switch were rotated such that when the hopper was stopped, the selector plate was not at the correct location. The consequences of this are that when the barrel opens to receive the primed sphere, the next sphere has not yet been loaded in the hopper and does not push the loaded sphere into the barrel.

To prevent further occurrence, a fourth screw will be added to prevent the motor plate from being installed in the incorrect orientation.

For existing units, users should ensure that the motor plate is reinstalled correctly after any maintenance to the hopper. See photograph:
