Technical Bulletin

Product Line: Bambi

Subject: Actuator Cable Guard

Reference: DC2014.09

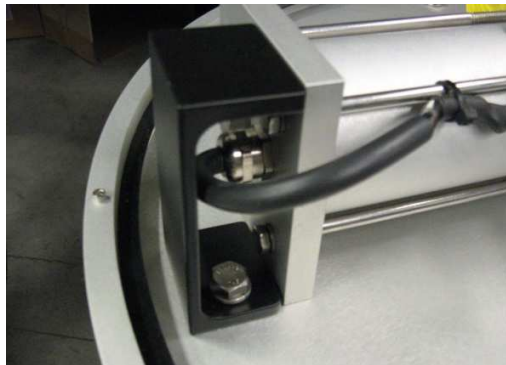
There have been multiple failures of Bambi MAX IVC's and actuators on the 25" valve. Investigation into the failures has identified the problem as damage to the electrical cable at the point it enters into the actuator. Water then enters the cable and migrates into the actuator and IVC causing a failure. The damage to the electrical cable is being caused by the IDS restrainer cable during deployment. In one case, the cable gland was torn off.

A cable guard has been added to protect the electrical cable and gland from damage. The guard mounts to the top plate of the valve using an existing bolt hole. The guard can be retrofitted in the field.
