Technical Bulletin

Product Line: Bambi

Models: Bambi Bucket 6072-1821

Subject: Small Tripline Design Change

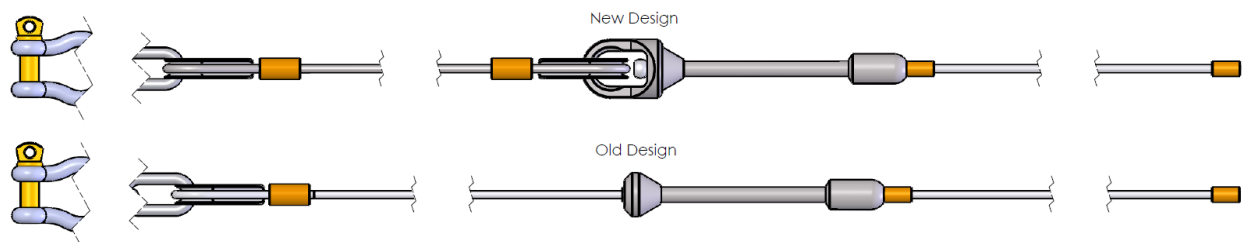
Triplines failing immediately below the bullet assembly has been a recurring issue on small Bambi Buckets. Several design changes have reduced the number of occurrences, but the issue has persisted on small buckets. The root cause on small buckets is believed to be the cable flexing as the bullet hits the pulley. A new design allows the cable to pivot freely immediately after the bullet to eliminate this issue.

The new designs 013055 and 013056 will replace 005335 and 005332 respectively. The new design is a direct replacement, and does not require any additional modification.

New triplines made by SEI will use the new design. Customers with the old design should continue to use those triplines if they have not encountered problems with them.
