Technical Bulletin

Date: July 16, 2020

Product: Bambi MAX Bucket (BBX)

Subject: IVC Voltage Clamp Addition

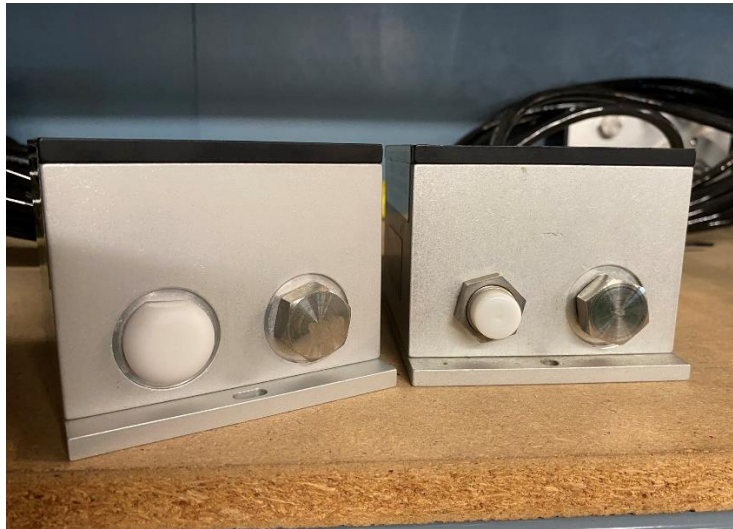
Figure 1: IVC 2 and IVC 1

All 25" and 28" valves with an IVC 2 (PN 015278) should have the Voltage Clamp installed. A distinction between an IVC 1 and IVC 2 can be seen on the following page (see Figure 1). IVC 1 will have the indicator light as shown on the right, and the IVC 2 will have the indicator light as shown on the left. IVC 1 does not require this installation.

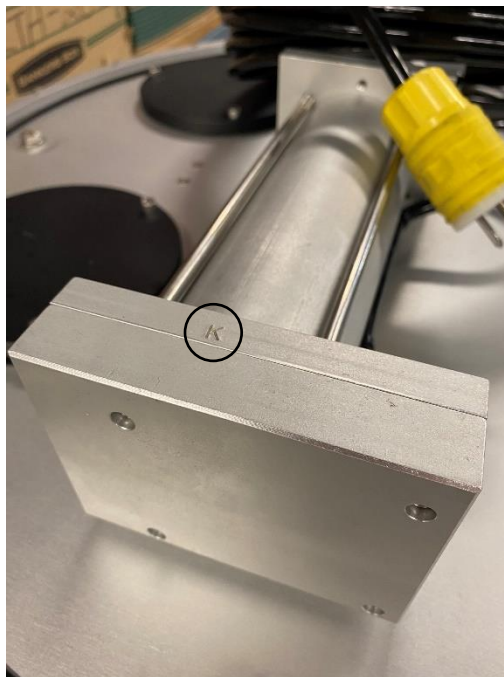
Figure 2: Motor Marked with the Letter "K"

A Voltage Clamp is not required on IVC 2s that have the letter “K” marked on the back of the motor as shown below (see Figure 2).

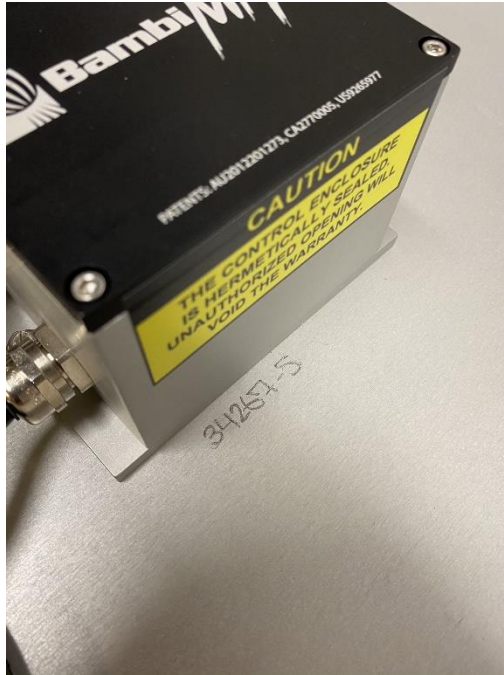
Figure 3: Serial Number Location

A Voltage Clamp is also not required for MAX valves that have a Serial Number (located below the caution label) above and including S/N 34267-5 (see Figure 3).

A Voltage Clamp must be installed if a new IVC assembly (P/N 015277 or 015278) is installed on a MAX valve that does not meet one of the above criteria.
