Issue Date: 12 JUL 10

Subject: Water Nozzle Leakage

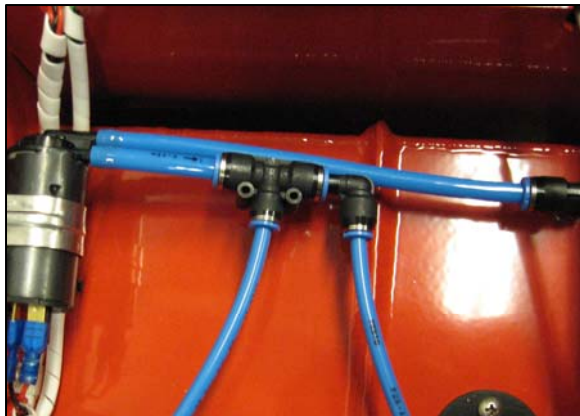
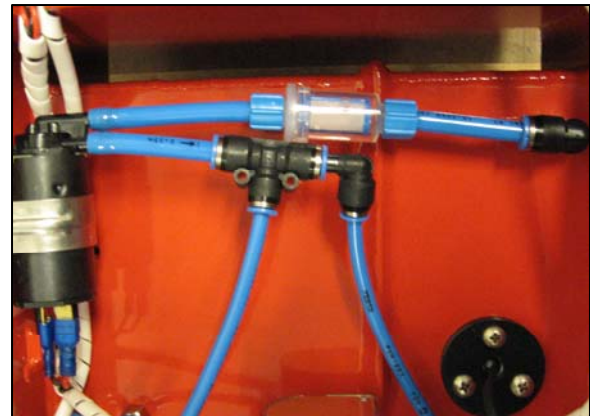
To prevent further occurrence, an in-line water filter kit is available as a field retrofit. The filter is a 50 micron screen that is installed on the suction side of the water pump. It has a clear housing so the status of the filter can be visibly checked and it can be cleaned by removing and back flushing with water.

The remedial action is to remove the check valve from the water nozzle and blow through with compressed air to clear any particulate. After cleaning, blow air in the reverse direction to confirm that the valve is closing.
