Technical Bulletin

Product Line: Bambi Bucket

Product: Bambi Bucket Standard

Subject: Standard Head Casting Inspection

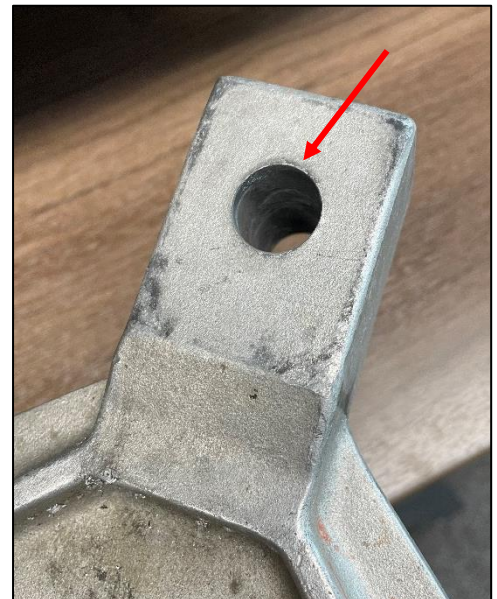
The small Bambi Bucket Control Head, found on sizes BB6072 - BB4453, is comprised of the Head Base, and the Yoke. This bolted connection is subjected to a small amount of movement during use, due to the clearance fit between the two components. As a result, the bolt hole in the head base may begin to wear. As the Yoke covers the Head Base, any damage may go un-noticed.

- It is recommended that the yoke be removed during regular (weekly) inspection of the head, to inspect the bolt hole for wear, and check the lug for signs of cracks.
- If the bucket collides with terrain (trees, etc.), the bucket should be grounded, and inspected **immediately**.
- If there is any visible damage to the Head Base, or Yoke, the parts shall be replaced. See the drawing below for the relevant part numbers.
